# Laboratory tests for the evaluation of the degradation of a photovoltaic plant of 2.85 MWp with different classes of PV modules

This paper studies and analyzes the results of performing several laboratory tests of a sample from a PV-plant with 2.85 MW of nominal power that has been in operation for 11 years and whose PV-modules are from different manufacturer and classes. The main purpose is to develop a proper quality inspection that allows knowing the degradation in a PV-plant with these special characteristics. The total sample has been taken in proportion to the size of each class through a proportionate allocation stratified sampling strategy. The tests performed on each sample were detailed visual inspection, power rating, electroluminescence (EL), and electrical insulation. The PV modules tested have been analyzed and evaluated according to an acceptance/rejection criteria established by the laboratory which has been based on International Electrotechnical Commission standards, bibliographic contributions and the warranty conditions of PV-modules. Considering the age of the plant and the criteria established in the power rating, the 80.01% of the sample modules were in go

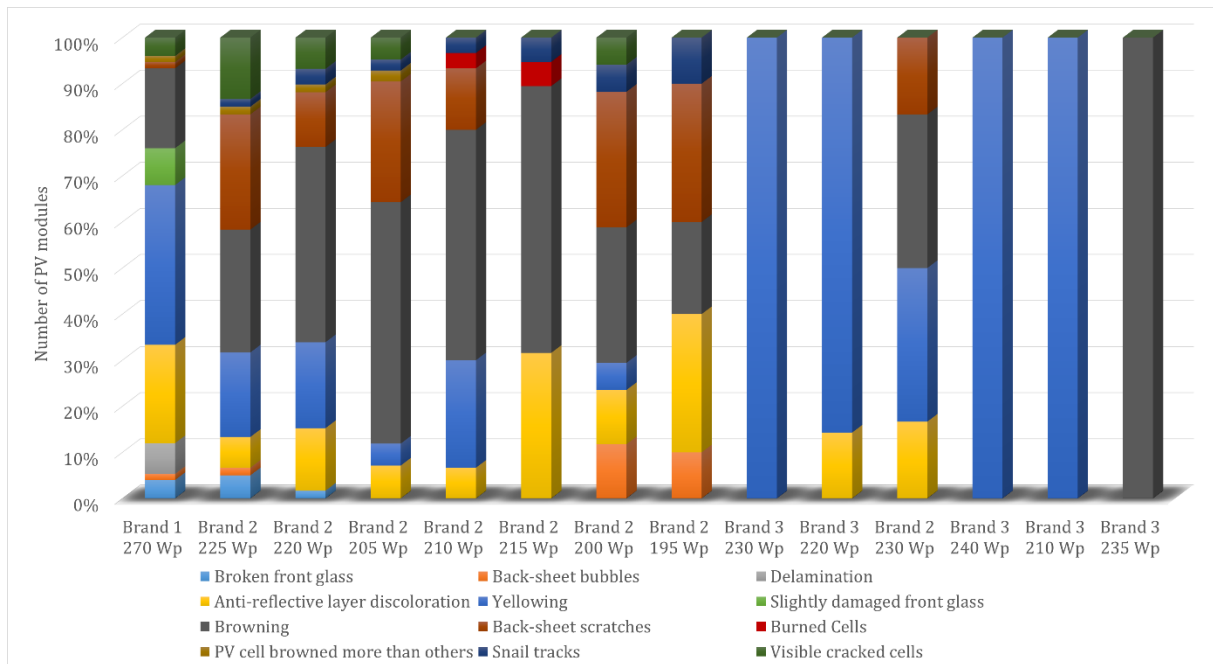
293 Fig. 3. Detailed visual inspection results by PV module class  
 294

289 Several defects have been found in the detailed visual inspection. Fig. 3 shows the different defects  
290 found for each PV module class, where it can be seen that the browning is the most recurrent  
291 defect, with a 29.95% of the total, followed by yellowing, back sheet scratches and anti-reflective  
292 layer, with the 21.39%, 12.57% and 12.03% respectively.

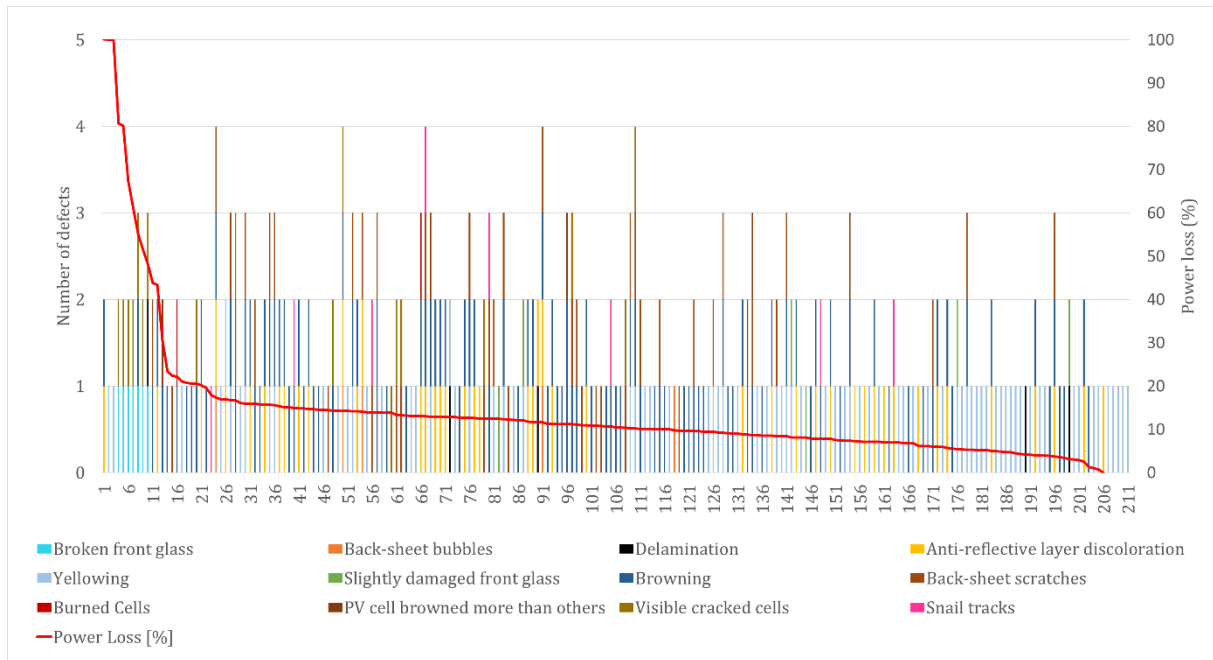
Fig. 5. Total number of visual defects in PV modules and its power loss associated

329 It has been assumed that the impact of each defect on the power loss is independent. However, it  
330 may be possible that some defect combined had a stronger impact on the power loss. Fig. 5 shows  
331 defectives PV modules and their associated power loss. In this figure, it can be seen that the  
332 maximum number of defects found in a single PV module is 4.

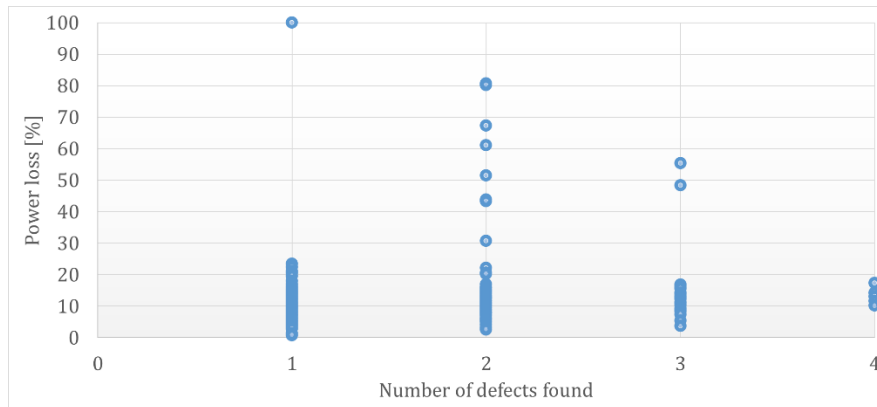
341  
342 Fig. 6. Grouping of defectives PV modules and its power loss associated

335 PV modules have been grouped according to the number of total defects found in each one. Fig. 6  
336 shows the groups created and its power loss, where each point represents a single PV module. It  
337 can be seen that power loss can vary widely without having any correlation. However, there is a  
338 light growing trend in the case of PV modules affected by 4 defects.

339 PV modules with 100% of power loss were due to internal disconnection in the junction box or  
340 connectors internal failure, which were not visible during this test.

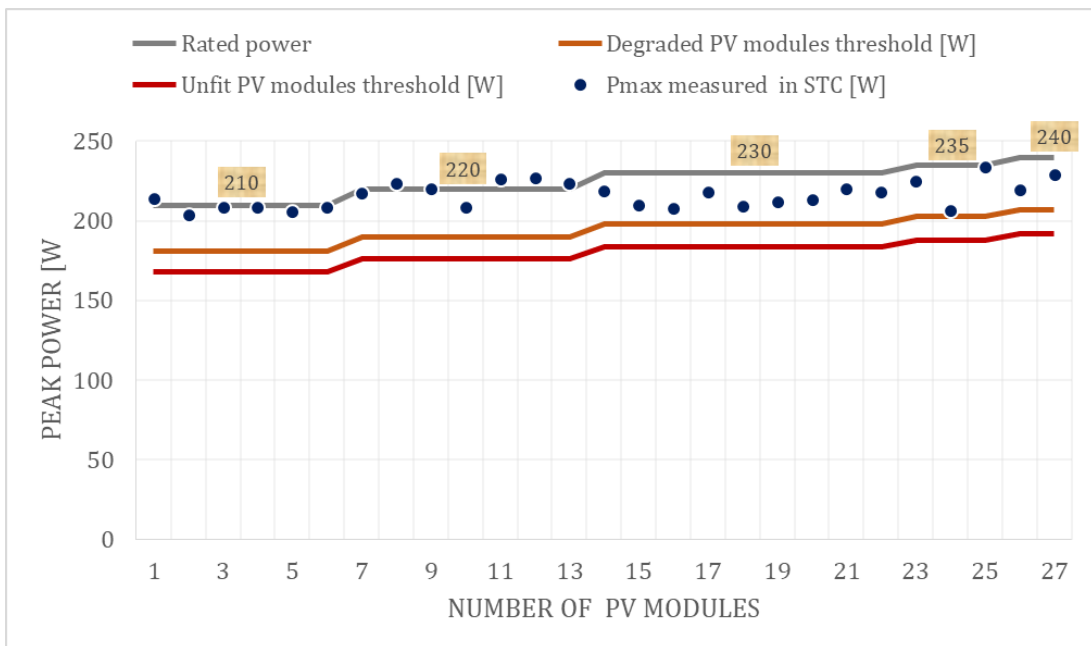
371 Fig. 9. Power rating results of PV modules brand 3.

364 Fig. 9 shows the peak power measured in STC of PV modules sample modules brand 3 from  
365 210Wp to 240Wp, where the 100% as resulted as fit. Based on the results obtained, this PV  
366 module brand has the best quality compared with the other brands installed in the PV plant. Due  
367 to the positive tolerance given by the manufacturer which is shown in Table I, in some cases, the  
368 peak power of the sample modules obtained got over the rated peak power obtained from the  
369 utility database.

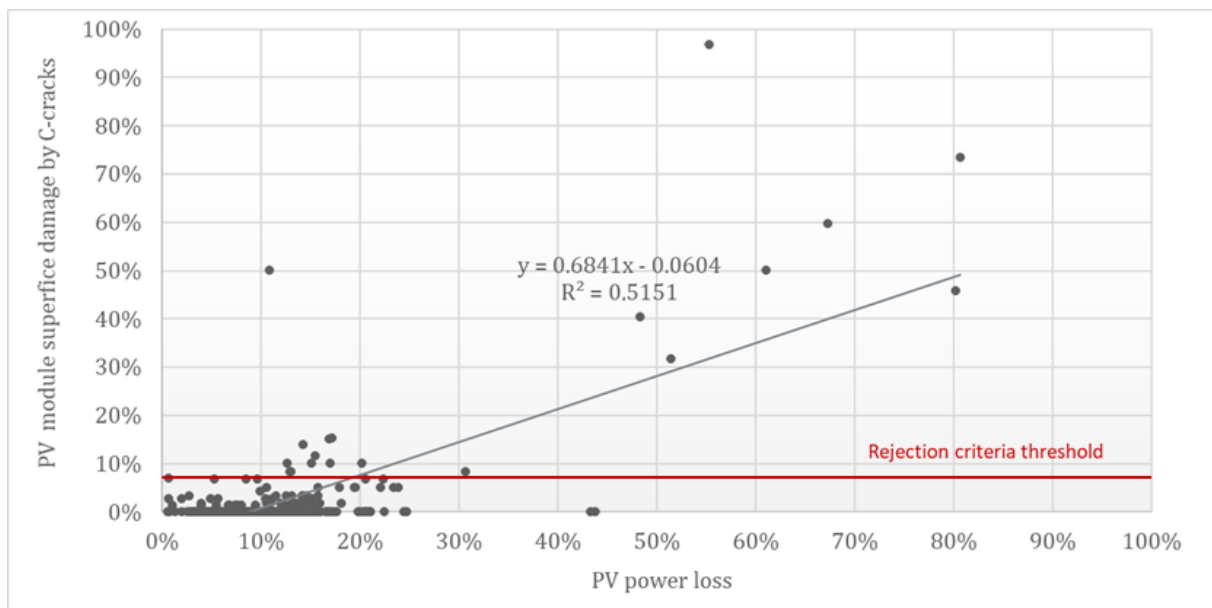
387  
388 Fig. 10. Relationship between the PV module area damage by C-cracks and the power loss of the  
389 sample modules tested.

378 In this figure, it can be observed that there exists some kind of relationship between the PV cell  
379 cracks type C and the power loss. However, although the correlation between both parameters is  
380 better than what has been obtained in [40], it has been considered that it remains weak  
381 ( $R^2=0.5151$ ). Others author in [21] considers that this relationship between the number of cell  
382 cracks in a PV module and its power loss is very noisy.

383 The red line drawn in Fig. 10 is the limit established by the laboratory for the evaluation of EL test.  
384 Thus, all sample modules that got over the red line had an area greater than the 8% affected by  
385 cracks type C and were all considered as non-acceptable. So, a total of 19 sample modules were  
386 rejected, of which 5 were modules brand 1 and 14 were modules brand 2.

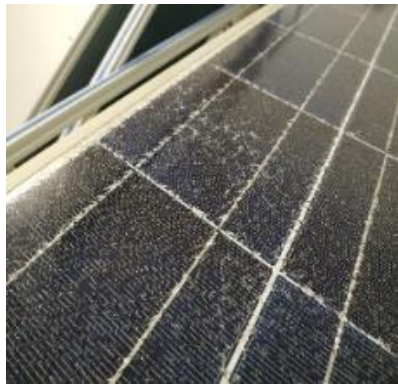
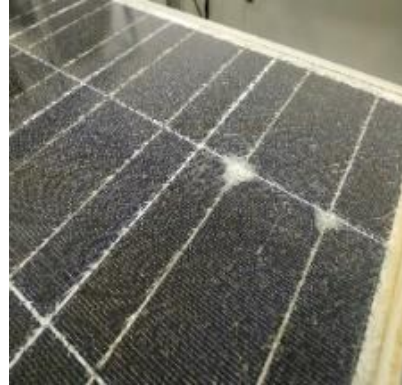
Fig. 12. Visual Inspection a) Cracked cells b) Broken front glass

408 However, it has been observed that some results obtained from EL and IR images show a certain  
 409 relationship between the inactive area and the hot-spot. Those modules affected by both cracks  
 410 and hot cells have a greater impact on the module performance [42]. An example has been  
 411 presented in this paper with the result obtained in the IR inspection made in-situ [28] and the EL  
 412 test performed in the laboratory. The sample chosen was the PV module brand 1 of 270Wp, which  
 413 showed a 49.49% of power loss during the I-V tracer test and some visible failures, such as broken  
 414 front-glass and visual cracked cell, were found in the detailed visual inspection. Both defects are  
 415 shown in fig. 12.

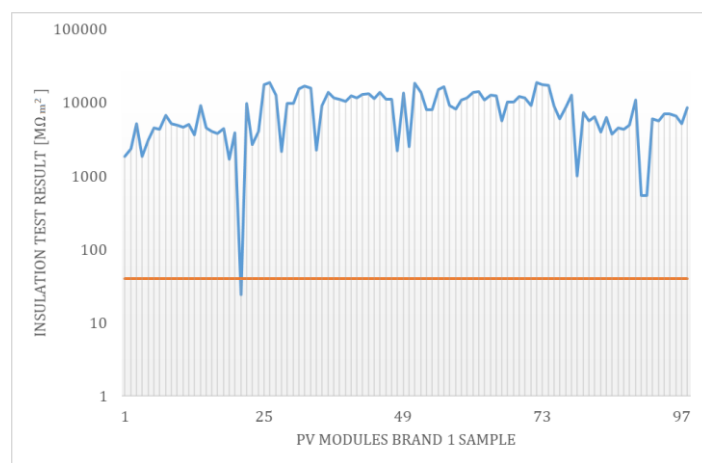
439 Fig. 14. Electrical insulation results in sample module brands 1.

435 Fig. 14-16 show the results of the electrical insulation test for sample modules brand 1, brand 2  
436 and brand 3 respectively. The orange line drawn in such figures is the rejected criteria reference  
437 value established by the IEC 61215-2:2016 [33].

444 From all the sample modules tested and as it is shown in fig. 14, only one module has resulted as  
445 non-acceptable. The PV module insulation resistance measured in such rejected sample was 24.06  
446  $M\Omega \cdot m^2$ .

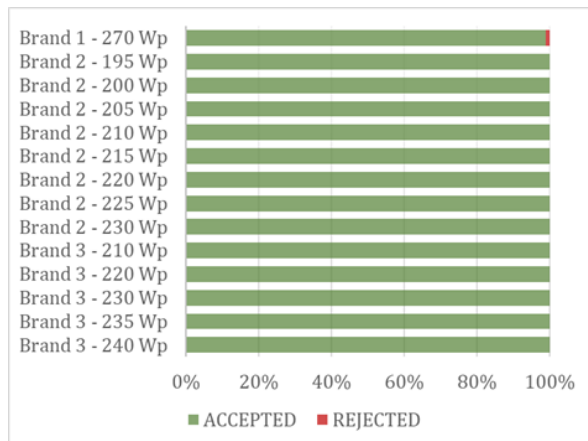
448 The overall results of the 4 test performed following the evaluation of each one and the  
449 acceptance/rejection criteria established in section 4 are shown in Fig. 17. Results for each test  
450 are shown by PV module class.

456 Fig. 17. a) shows the results of the detailed visual inspection where the accepted ones have been  
 457 colored in green while rejected ones have been colored in red. The PV module class with the  
 458 greatest percentage of failure has been the brand 2 of 225Wp with the 8.16% followed by brand  
 459 2 of 215Wp and 210Wp, both with the 3.33%. Clustering by manufacturer, the percentage of  
 460 failures found in brand 1, brand 2 and brand 3 would be the 4.08%, 3.83% and 0.00% respectively.  
 461 Globally, only the 3.61% were rejected in the detailed visual inspection.

462 Fig. 17 b) shows the results of the power rating test and the acceptance/rejection criteria, where  
 463 accepted, degraded and rejected sample modules were colored in green, orange and red  
 464 respectively. In this case, the PV module brand 2 of 225Wp, 215Wp and 210Wp, with the 20.41%,  
 465 16.67% and 11.11% respectively, were the classes with the greatest percentage of non-  
 466 acceptance. In terms of degradation, the PV module brand 2 of 200Wp, 215Wp and 210Wp, with  
 467 the 30.00%, 20.00% and 16.67% respectively, were the most affected by. Clustering by  
 468 manufacturer, the percentage of rejected of brand 1, brand 2 and brand 3 were 7.14%, 11.91%  
 469 and 0.00% respectively. If all the sample modules are grouped, the 80.00% of the PV modules  
 470 tested were found to be in good condition, the 10.27% degraded and the 9.72% rejected.

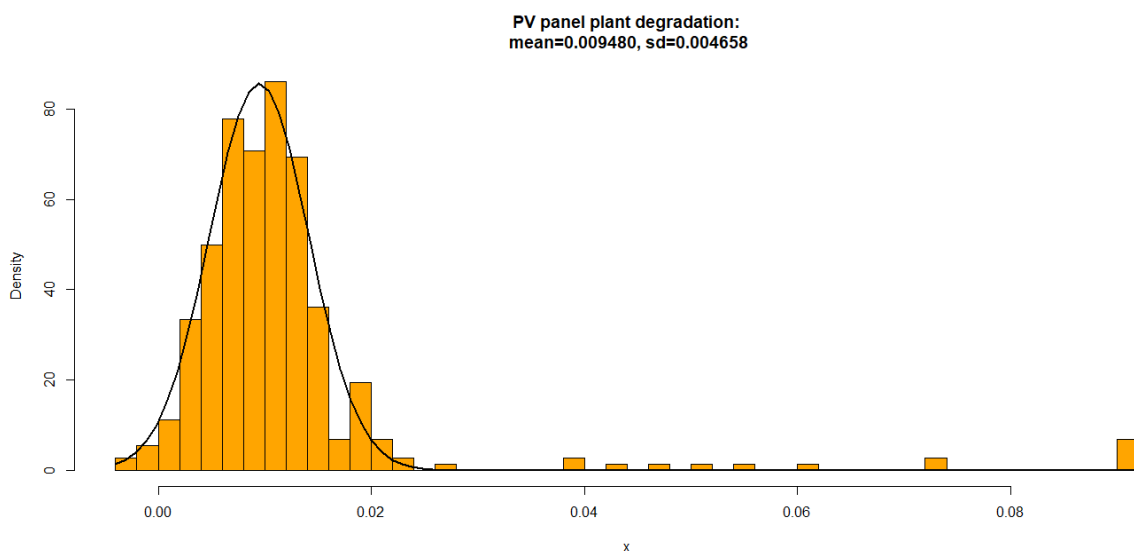
519  
520 Fig. 22. Histogram and approximation of PDF (normal distribution,  $\bar{x} = 0.009480, sd =$   
521  $0.004658$ ) to all the sample modules.

513 Fig. 22 shows the histogram and its corresponding PDF when all the sample modules are studied  
514 together. In this case, the PDF obtained also resulted in fitting well with a normal distribution,  
515 which has been obtained applying a non-linear regression fitting the least square using the Gauss-  
516 Newton algorithm. The average annual degradation rate resulted in 0.94%/year while its lower  
517 and upper bounds with a c.i. of 95% according to a normal distribution were 0.89%/year and  
518 0.99%/year respectively.
